PROJECT PROFILE DSC Logistics Warehouse

DSC Logistics Warehouse
Colonial Heights, VA

Sarnafast System, mechanically attached, 60-mil S327 EnergySmart Roof® membrane

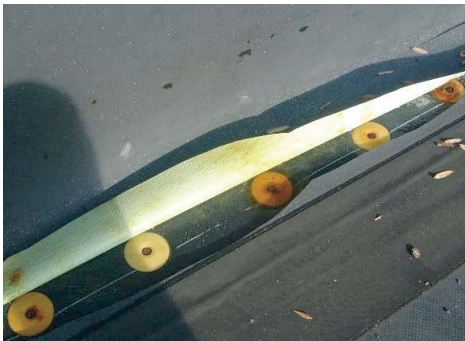
After only six years, the steel fasteners used to secure the former TPO membrane were rusted due to water infiltration through thousands of tiny pin holes that had developed.

Extensive repairs had already been made on the roof system, but the building's leakage problems continued. The six-year-old TPO roof membrane experienced advanced oxidation and loss of thickness of the exposed membrane surface to the point that pin holes appeared around the reinforcement scrim.

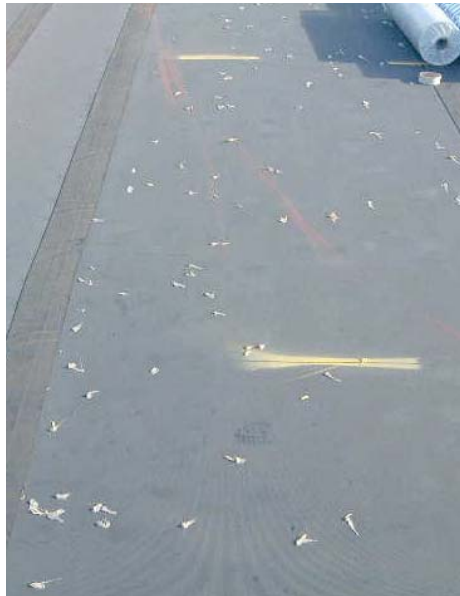
Advanced oxidation and loss of thickness of the exposed TPO membrane caused thousands of tiny pin holes to appear around the reinforcement scrim. To speed the installation process, grey caulking was used to cover many of the pin holes before the Sarnafil membrane was installed. The yellow lines were used to mark areas of the TPO that were leaking.
