# Project Profile

Carver-Hawkeye Arena  
Iowa City, IA

## **Sika Sarnafil Roofing System on Carver-Hawkeye Arena Wins Big – Twice!**

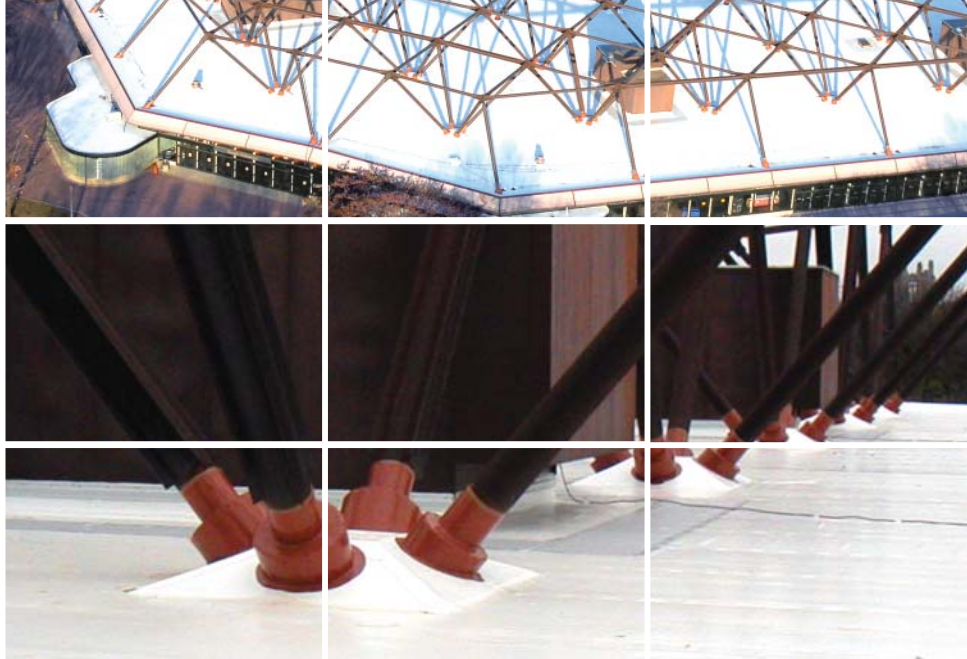
The roof is supported by exposed Cor-Ten steel trusses, so CEI used copper brown colored Sarnafil flashing membrane on truss column bases.
